AFWAL-TR-85-2006

**COMPATIBILITY OF SODIUM AND
LITHIUM IN SUPERALLOY HEAT PIPES**

April 1985

Final Report for Period 1 January - 31 December 84

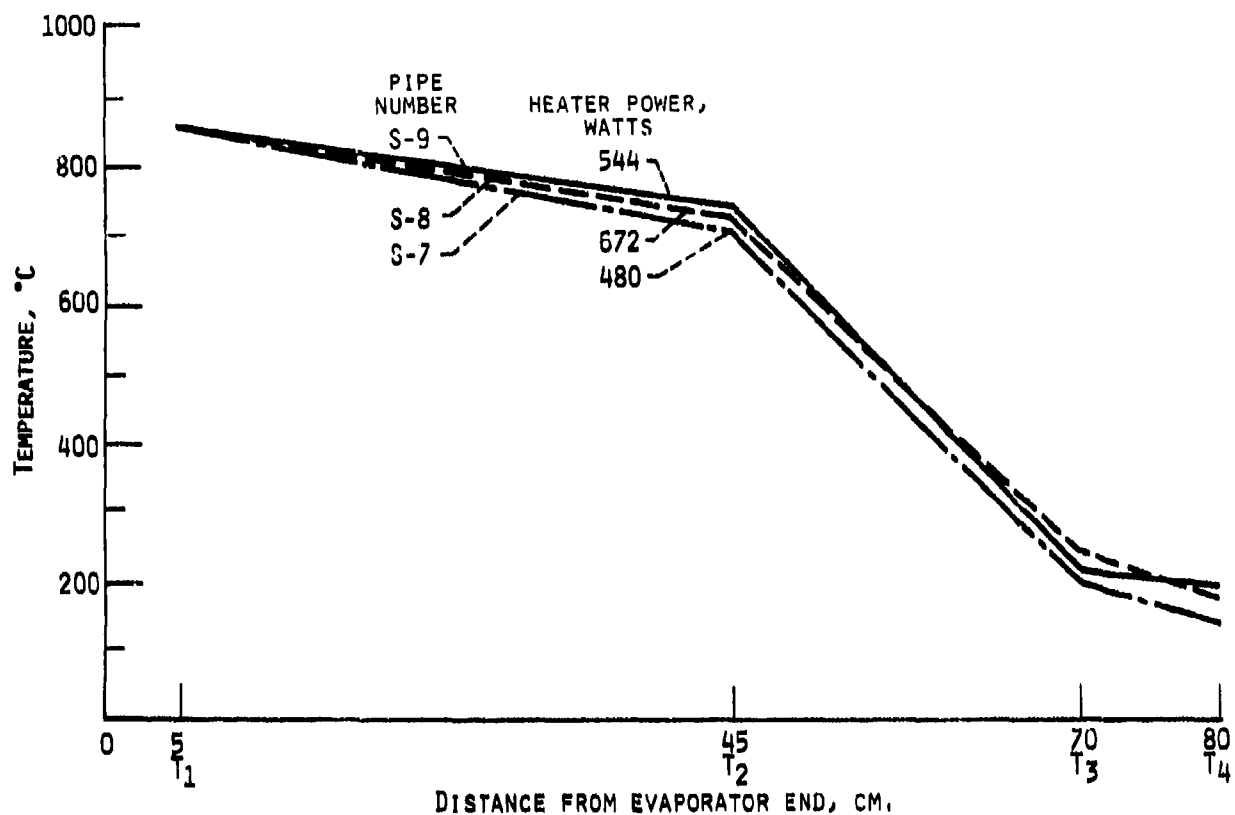
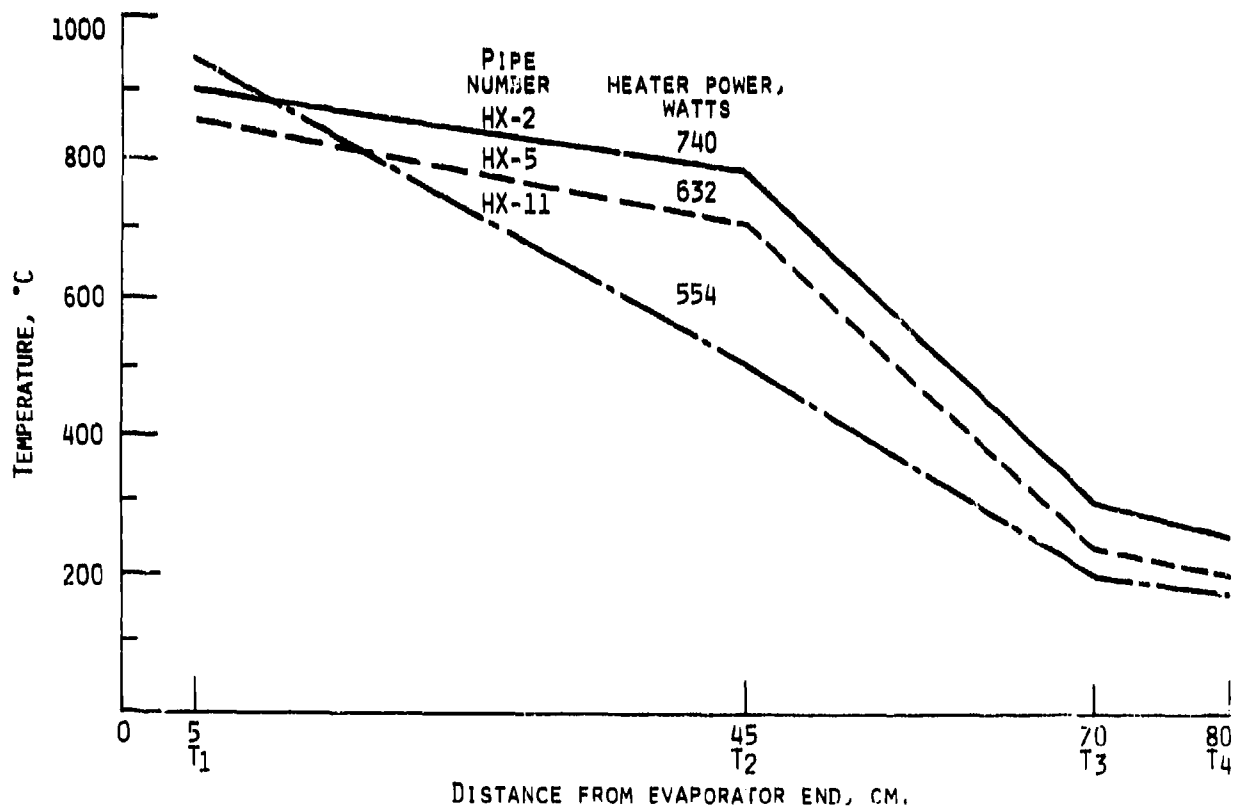
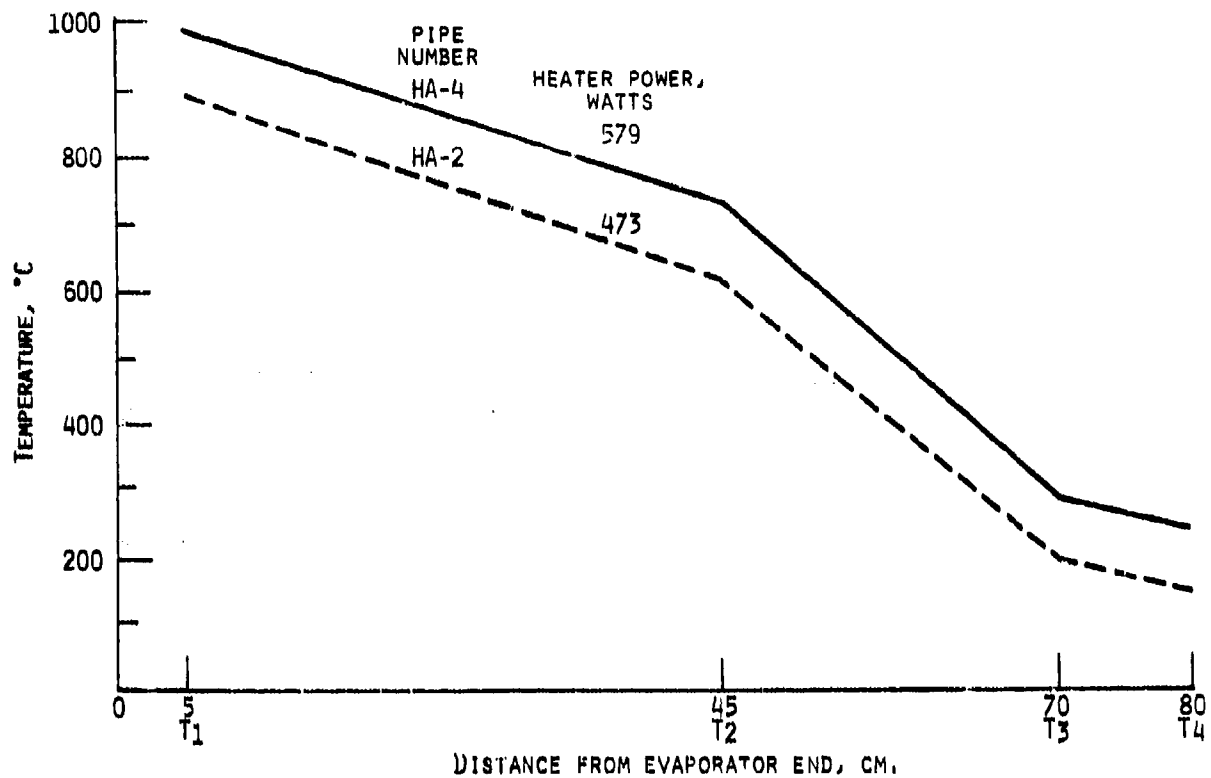
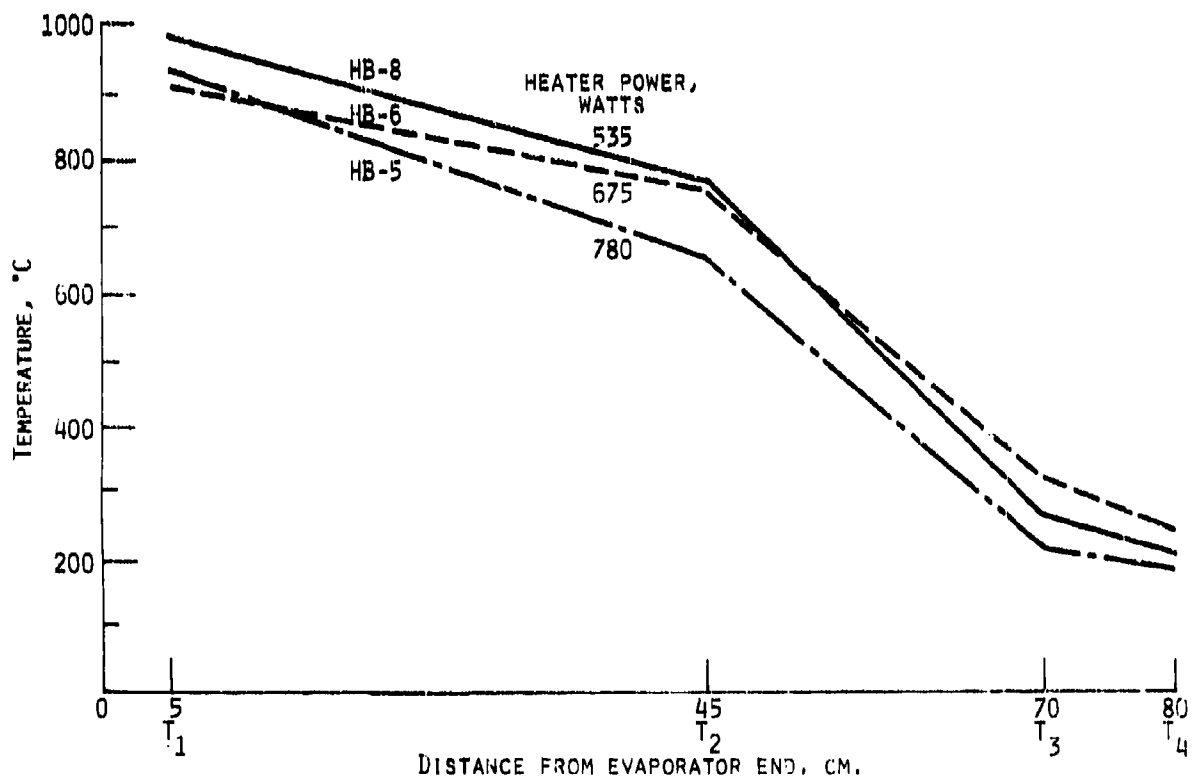
Steady state profiles along lithium pipes are shown in Fig. 12. Those for 310S stainless steel pipes, S-7, S-8, and S-9 which had 60 mesh screen wicks are essentially the same as those for the pipes with metal fiber wicks. Since the pipes were heated along the 30.5 cm long

(A) SCREEN WICK, 310S PIPES.

FIGURE 12. - TYPICAL STEADY-STATE TEMPERATURE PROFILES FOR LITHIUM-FILLED PIPES.

(B) METAL FIBER WICKS, HASTALLOY X PIPES.

(c) METAL FIBER WICKS, HAYNES 188 PIPES.

(d) METAL FIBER WICKS, HASTALLOY B PIPES.

evaporator, one might expect the indicated temperature at T_2 to be due to heat conduction down the pipe walls. However, in Section V evidence is presented to indicate that the observed performance is possibly all that might have been attainable at the temperatures reached.

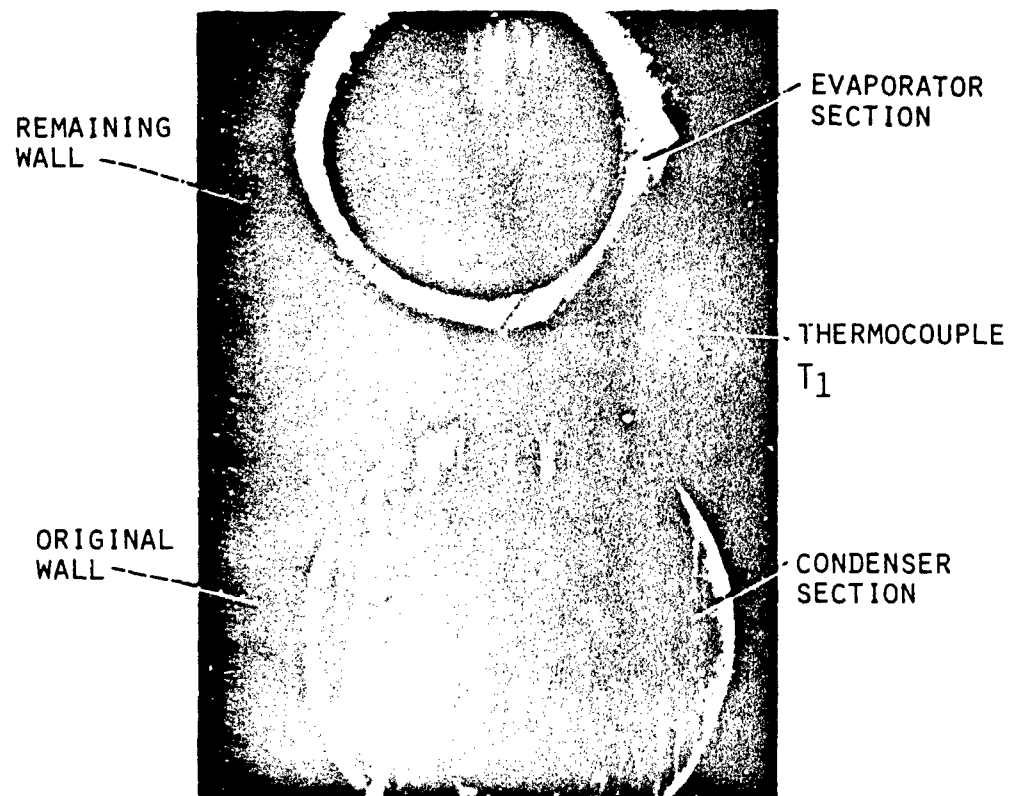
The extent of external oxidation can be seen more clearly in Fig. 14. Figure 14(a) presents a cross section of the evaporator at the location of thermocouple no. 1, 5 cm from the evaporator end along with a cross section at about 3.8 cm from the condenser end. Figure 14(b) shows

(A) COMPARISON OF EVAPORATOR AND CONDENSER CROSS-SECTIONS OF PIPE L-2.

(B) EXTERNAL COATING AND SCALING, EVAPORATOR END, PIPE L-2.

FIGURE 14. - EXTERNAL/INTERNAL CORROSION IN STAINLESS STEEL 304L PIPES.

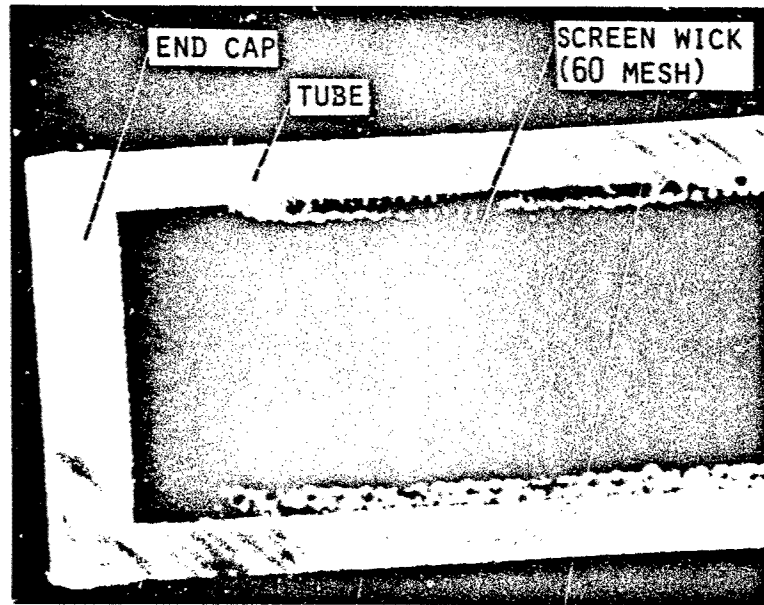
FIGURE 15. - LONGITUDINAL SECTION OF EVAPORATOR END OF 310S STAINLESS STEEL PIPE S-1.

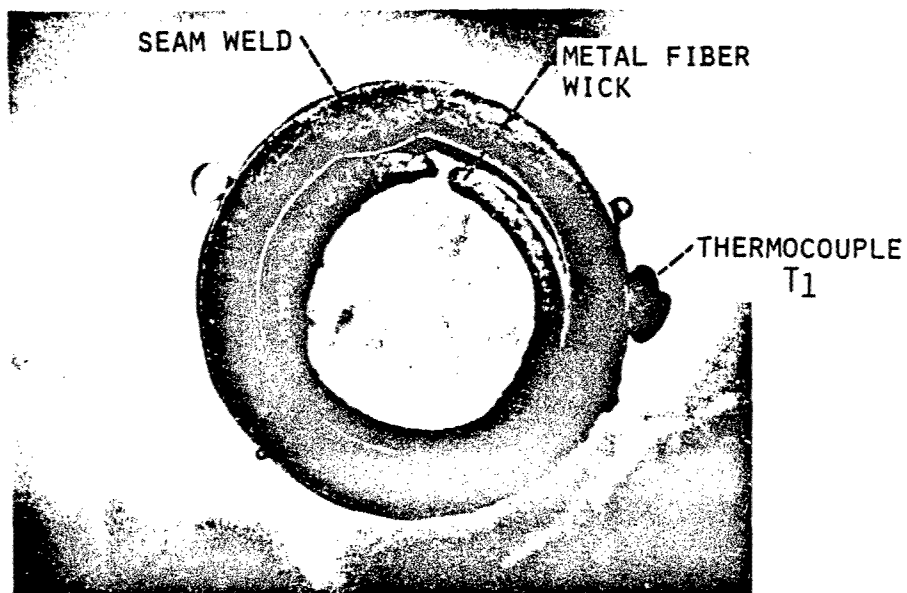
(A) CROSS SECTION OF EVAPORATOR TIP.

(B) CROSS SECTION AT T_1 .

FIGURE 20. - SECTIONS OF HASTALLOY B PIPE
HB-1.

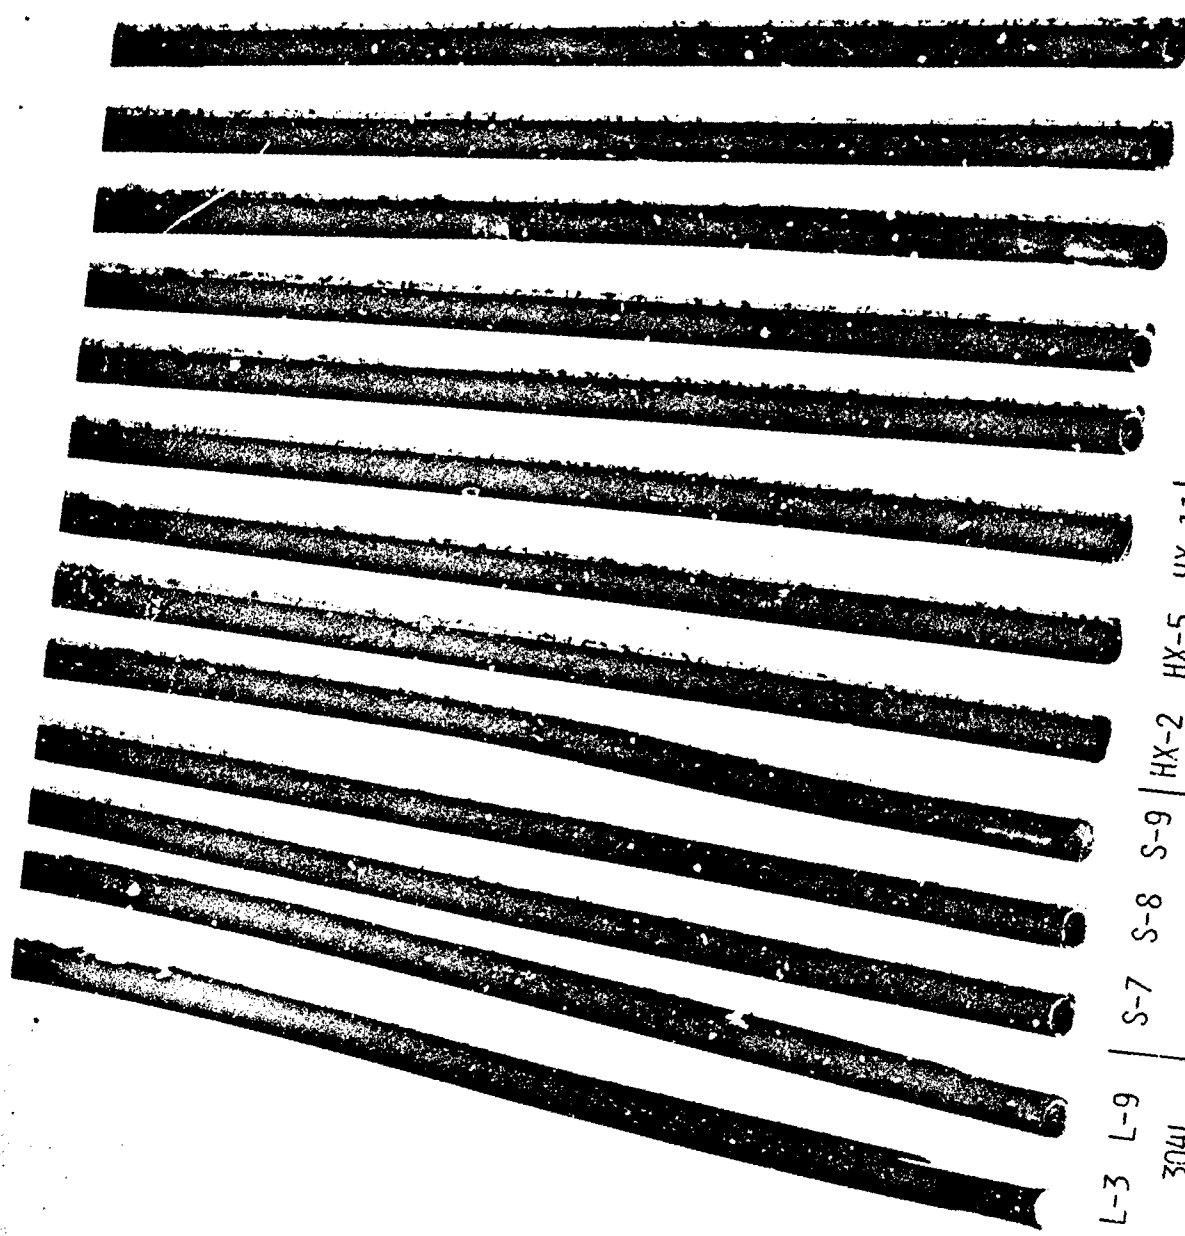
L-3 L-9 | S-7 S-8 S-9 | HX-2 HX-5 HX-11 | HA-1 HA-2 HA-3 | HB-5 HB-8
 304L | 310S | HASTALLOY X | HAYNES 188 | HASTALLOY B
 FIGURE 21. - EVAPORATOR ENDS OF HEAT PIPES OPERATED IN VACUUM ENVIRONMENT.

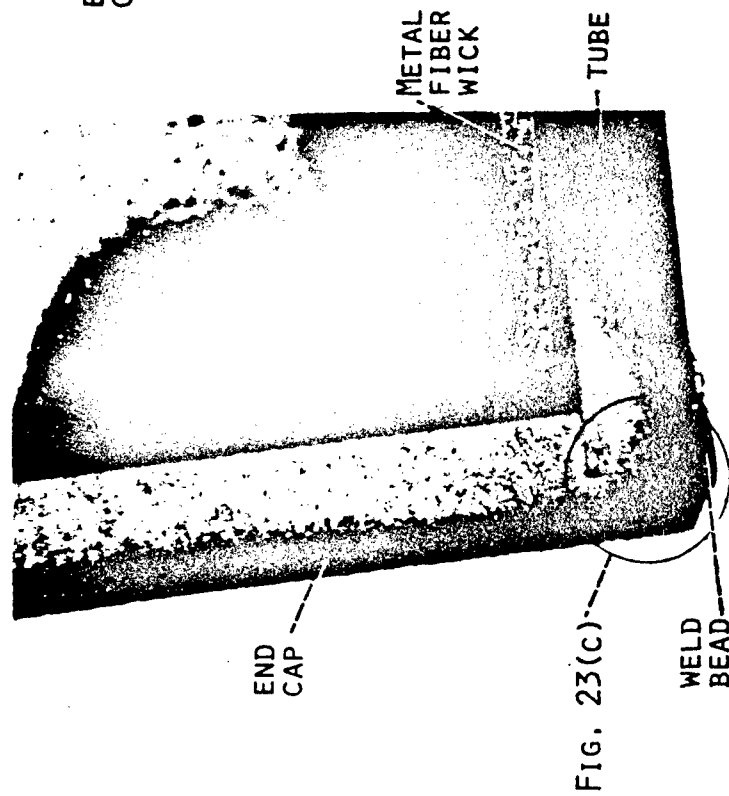
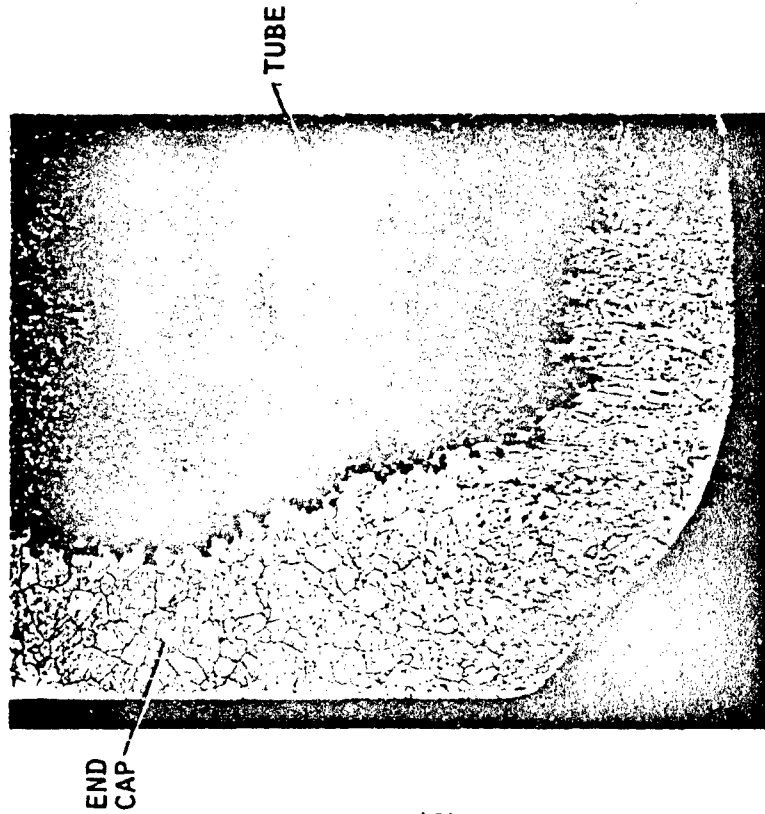
(A) LONGITUDINAL SECTION OF EVAPORATOR END.
FIGURE 23. - LITHIUM ATTACK ON INTERNAL SUR-
FACES OF EVAPORATOR END OF HASTALLOY PIPE
HX-11.

(B) END CAP TO TUBE JOINT, MAGNIFICATION 10X.

(C) LITHIUM PENETRATION INTO END CAP TO TUBE JOINT AREA, MAGNIFICATION 50X.

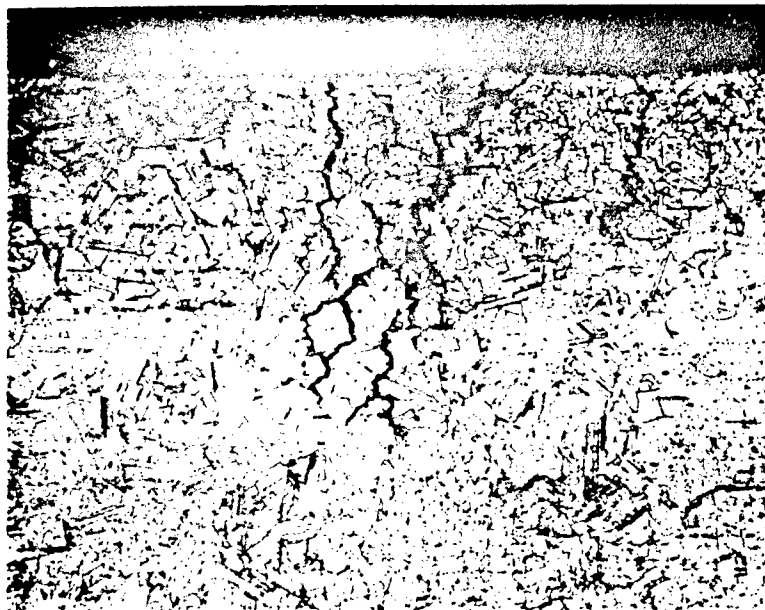
(A) CRACKS IN EXTERNAL SURFACE,
MAGNIFICATION 100X.

(B) SECTION AT CRACKS, MAGNIFICATION 100X.

FIGURE 26. - WALL CRACKS IN EVAPORATOR END OF
HAYNES 188 PIPE HA-1.

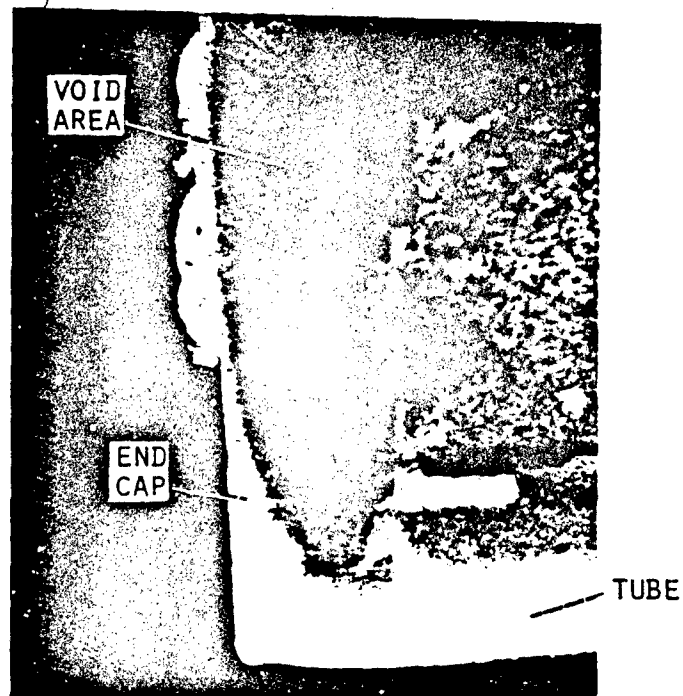
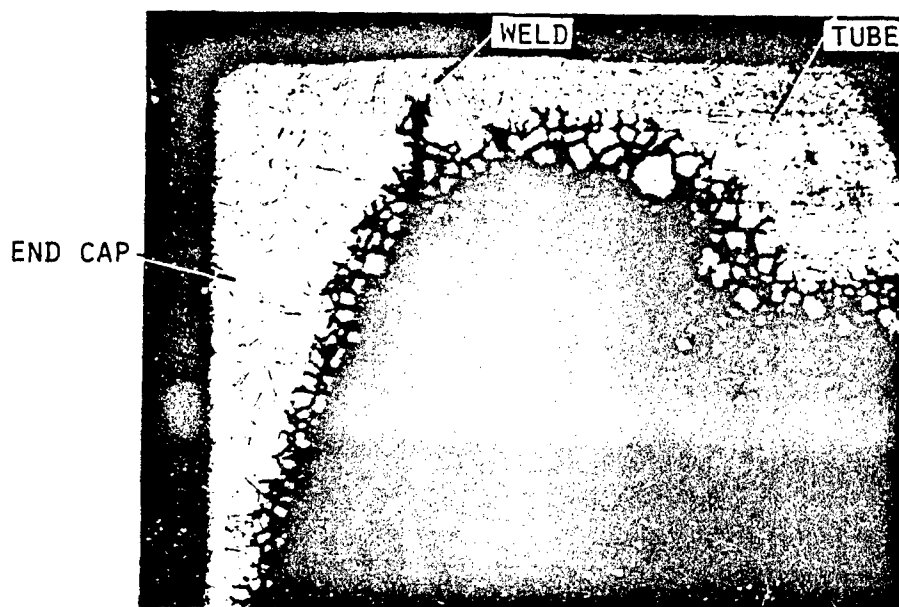
(A) VOIDS IN END CAP CAUSED BY LITHIUM ATTACK.

(B) PHOTOMICROGRAPH OF END CAP TO TUBE JOINT, MAGNIFICATION 30X.

FIGURE 29. - LITHIUM ATTACK ON EVAPORATOR END OF HASTALLOY B PIPE HB-6.

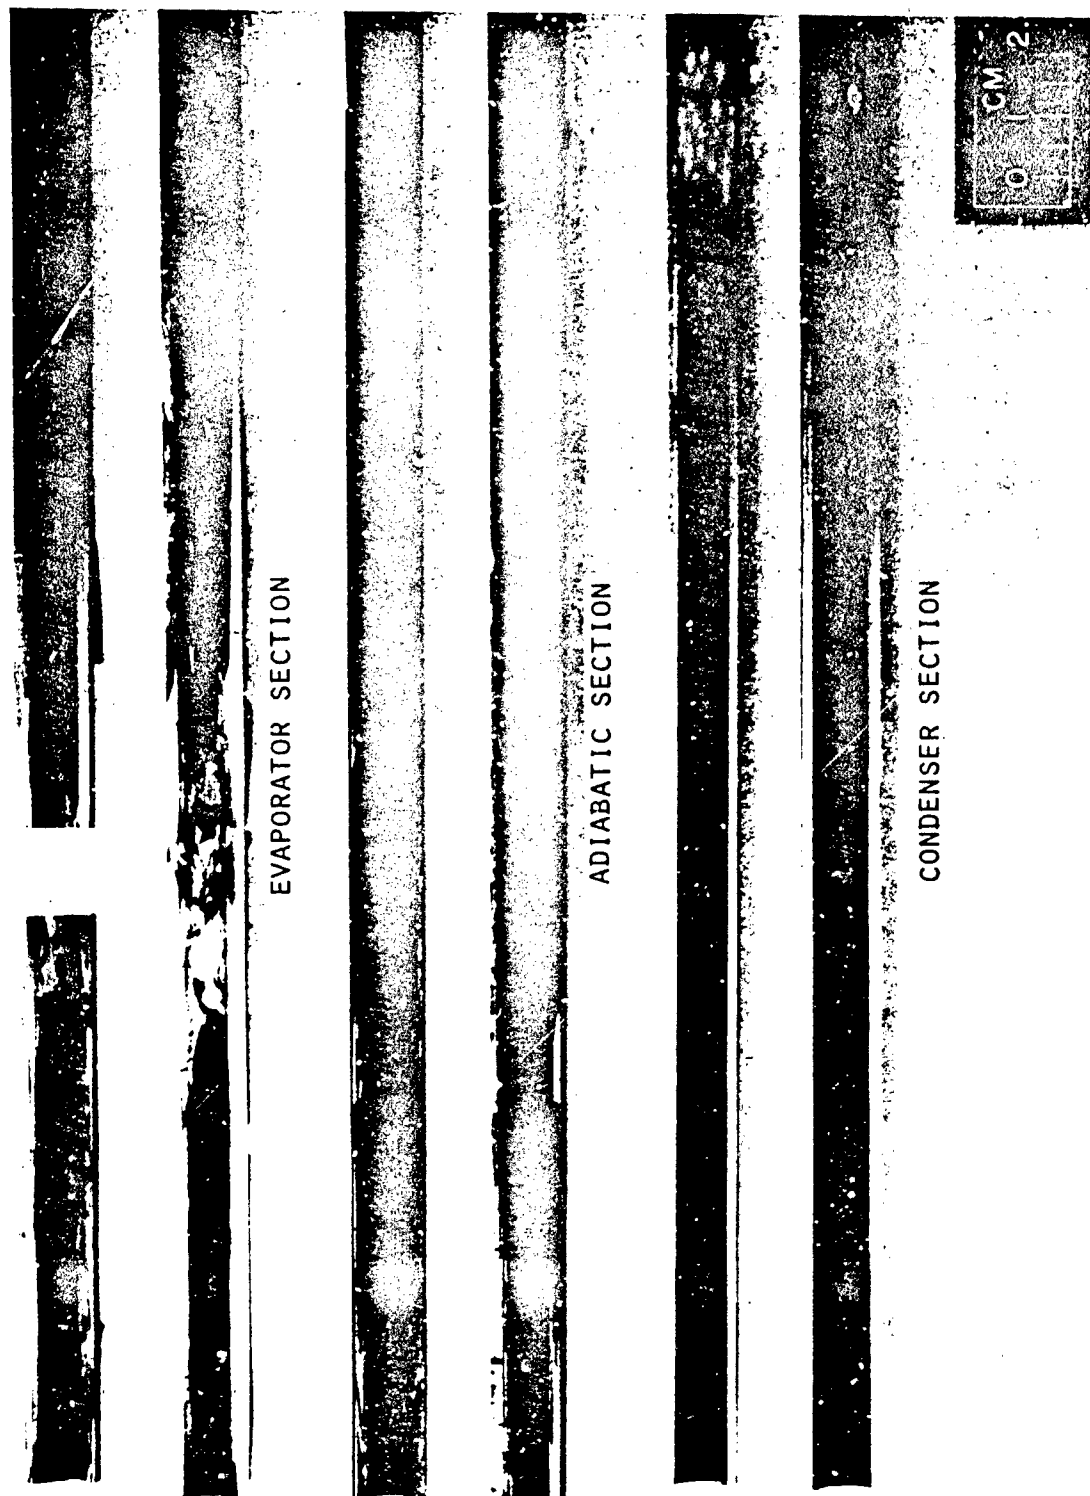
FIGURE 31. - LONGITUDINAL SECTIONS OF HASTALLOY B PIPE HB-6 SHOWING EXTENT OF LITHIUM CORROSION ALONG ENTIRE LENGTH OF PIPE.

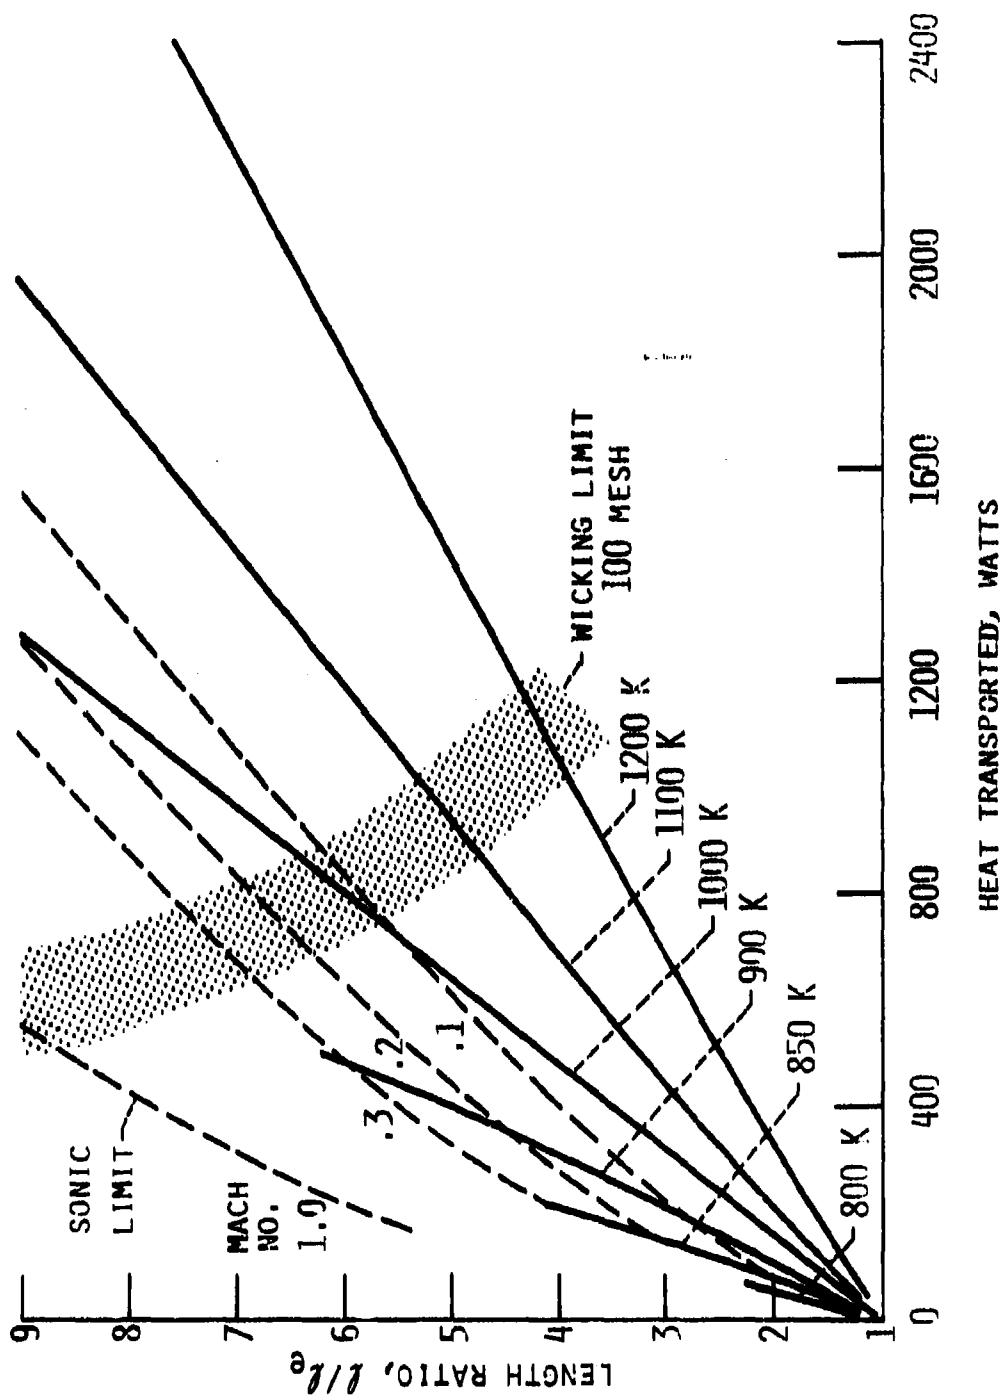
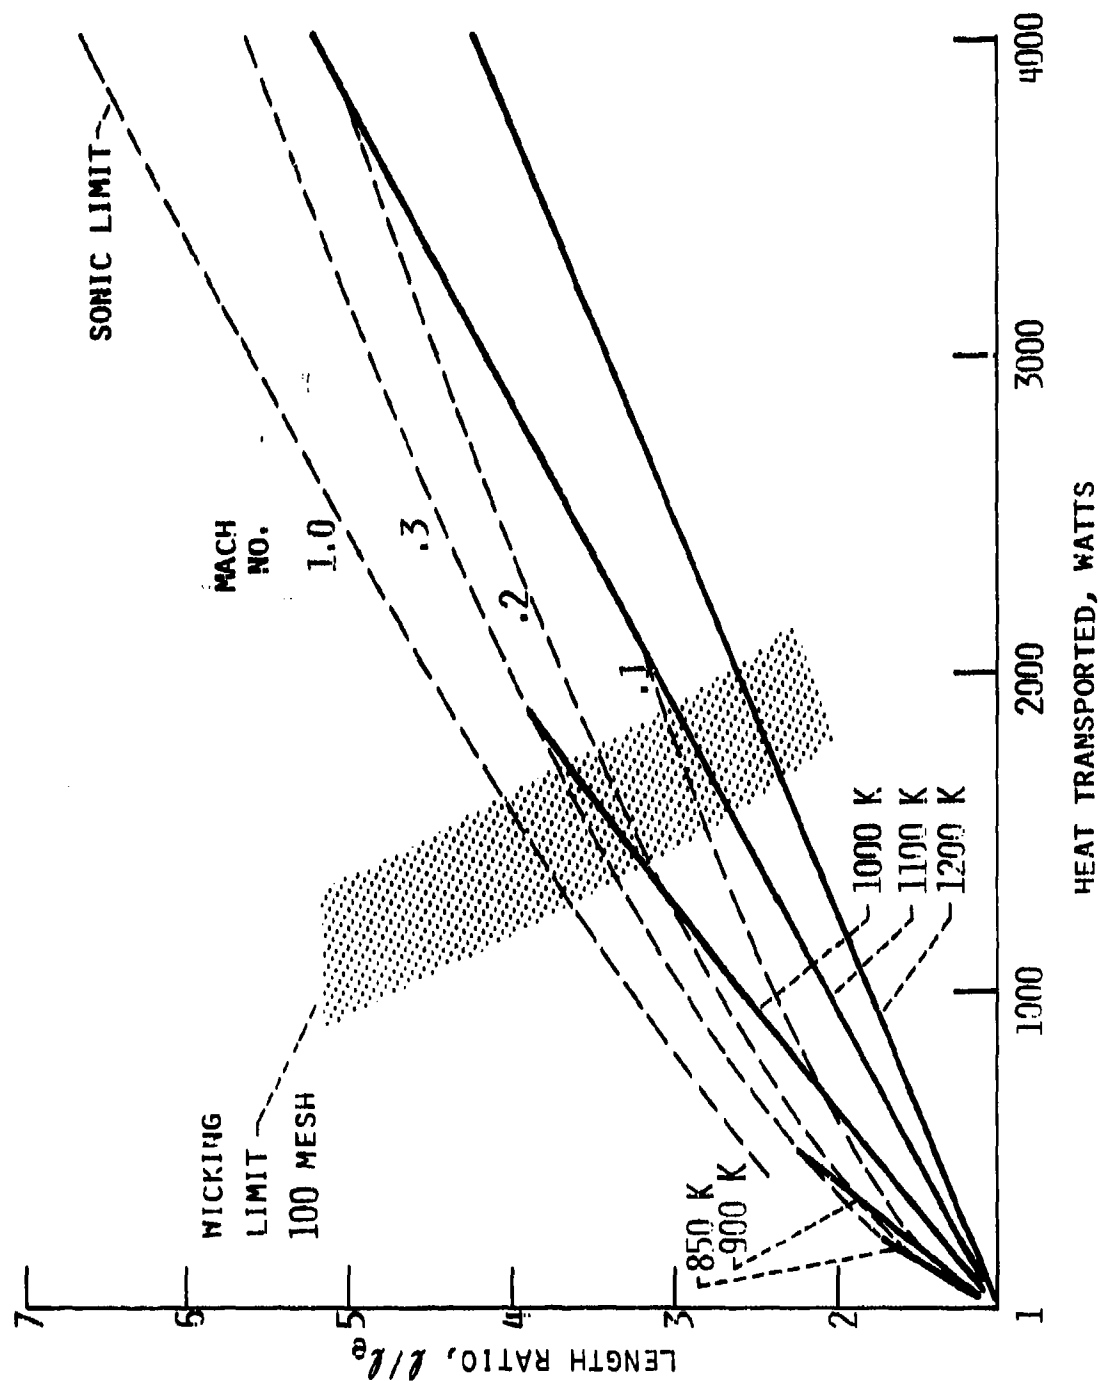
Also shown in Figs. 33(a) and (b) are hatched regions representing approximate wicking limit for 100 mesh screen as computed from experimental data taken in the program. The width of the zone suggests uncertainty in the computation, but is in no way proportional to the uncertainty. Appendix A discusses the computations leading to the location of this region. An analytic determination of the wicking limit using published values of wick permeability and wicking capability gives a heat transport as low as 75 W at ℓ/ℓ_e of 3, the physical dimension of the

(A) CONDENSER EMISSIVITY, 9.25.

FIGURE 33. LENGTH OF SODIUM-FILLED PIPE REQUIRED TO DISSIPATE TRANSPORTED HEAT AT SEVERAL TEMPERATURES.

(3) CONDENSER EMISSIVITY, 1.0.

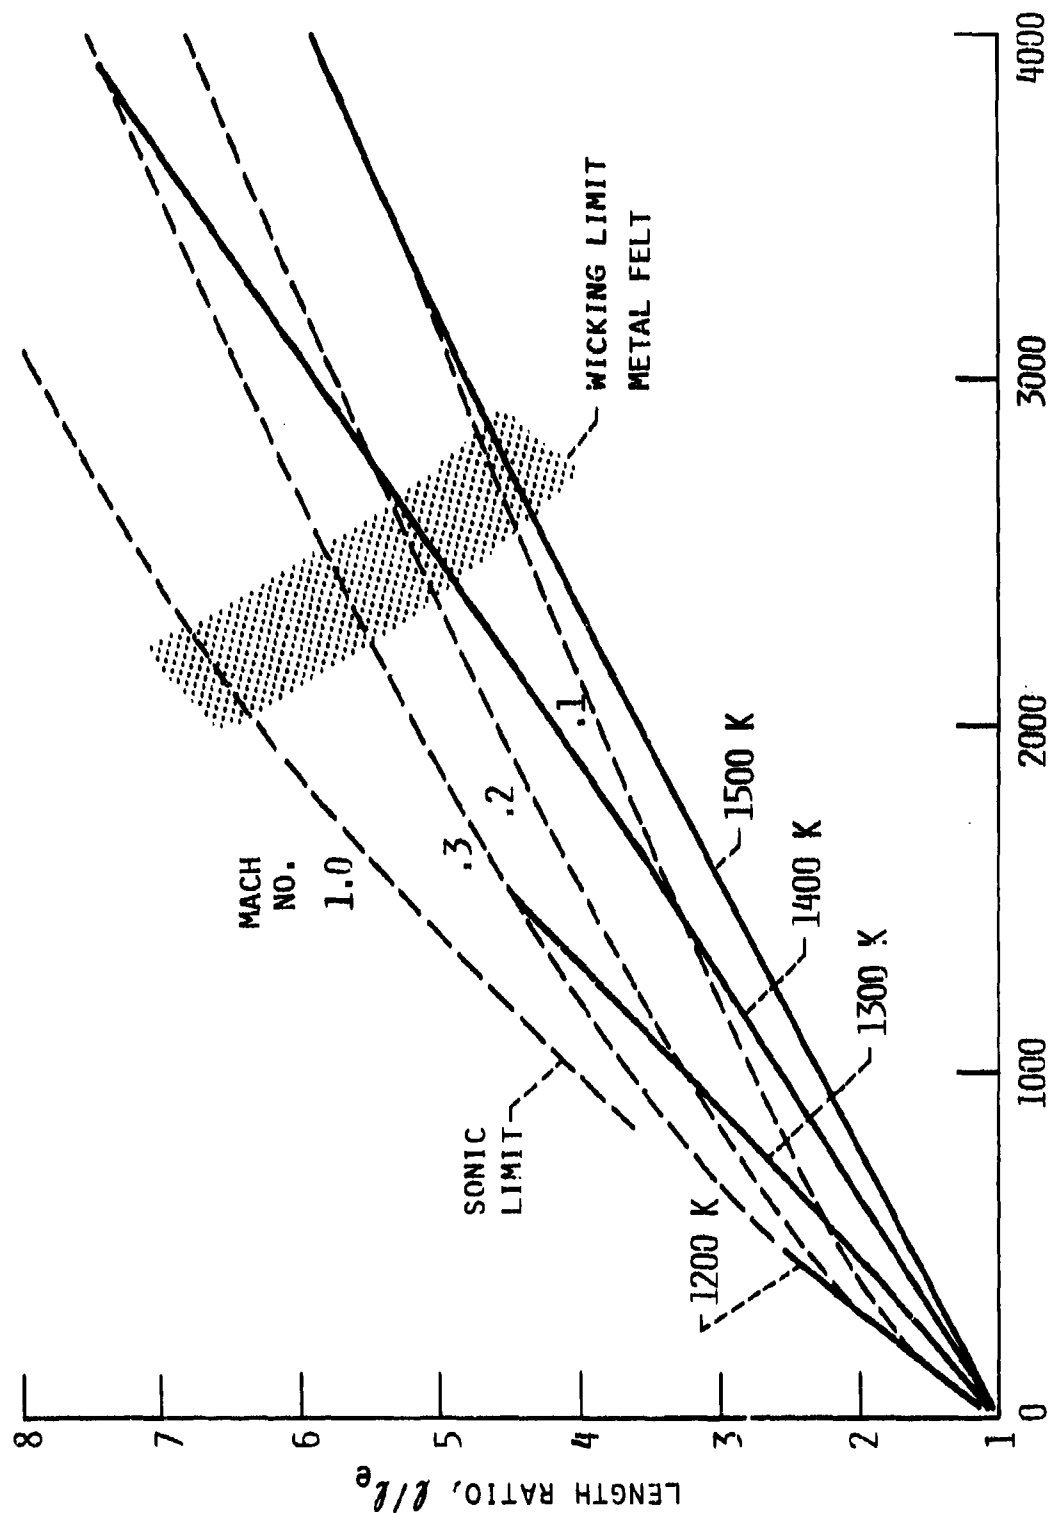
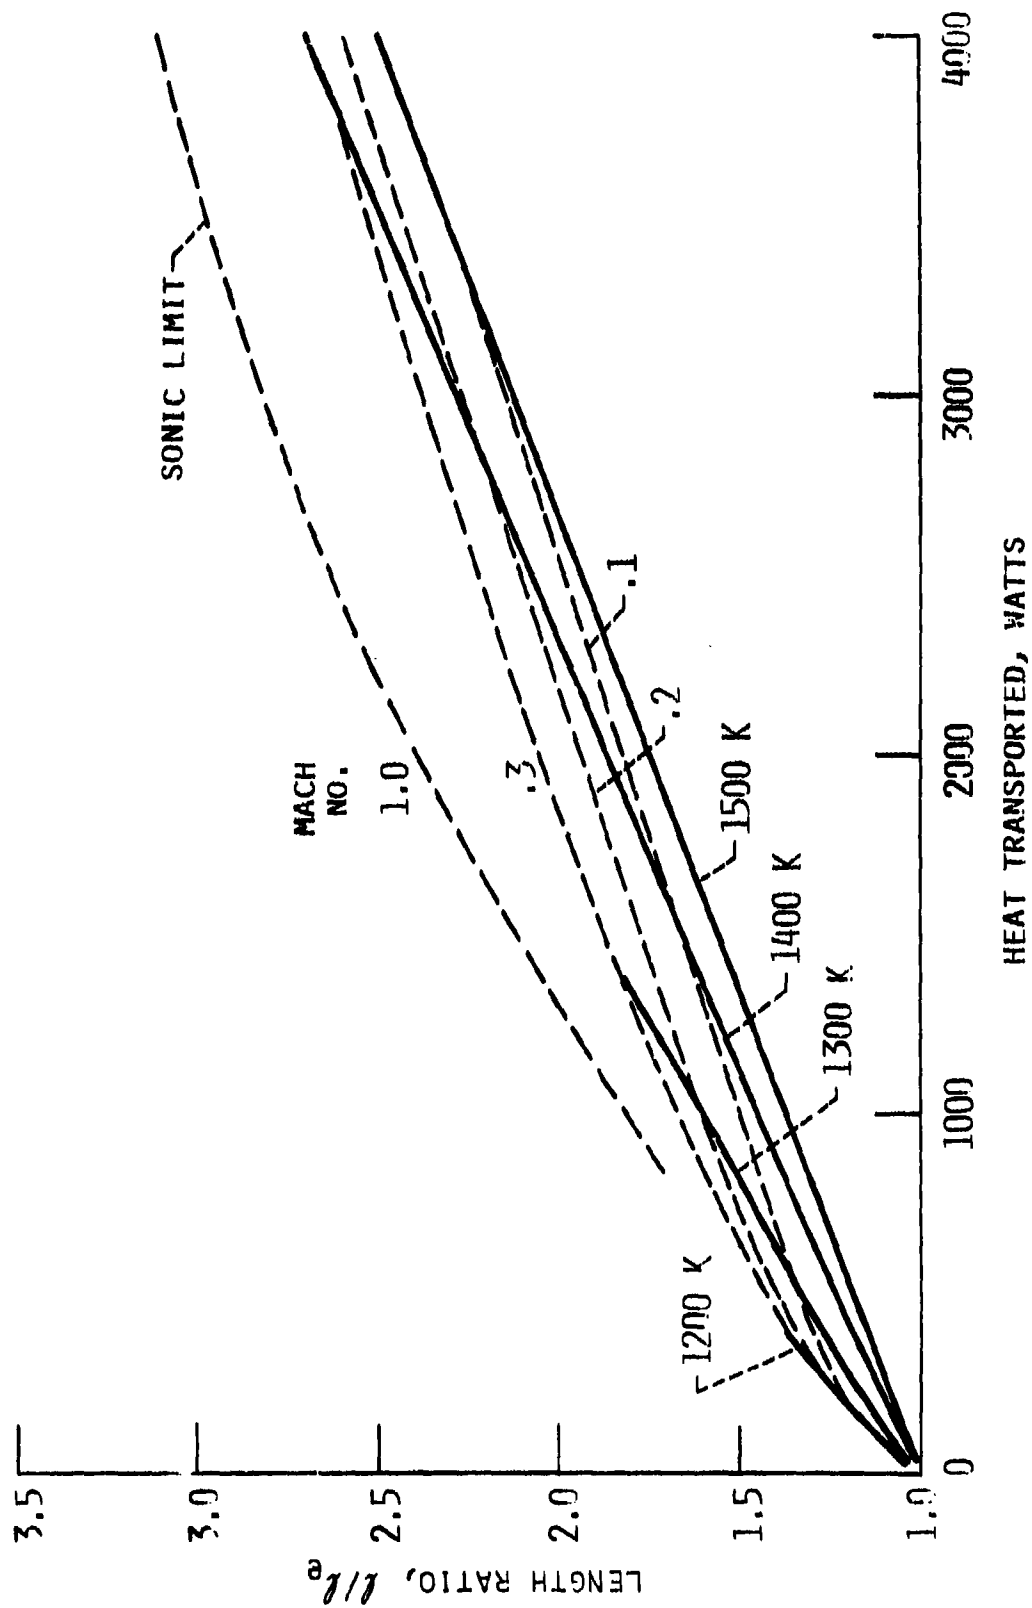
The wicking limit in Fig. 34(a) represents a computation for metal felt wicks. The wicking limit falls to the right of the grid in Fig. 34(b). While no known wicking limit was encountered in the tests with the lithium pipes, evidence of incipient dryout was observed in sodium pipes with metal felt wicks. As described in Appendix A, this information was used to deduce a metal felt flow

FIGURE 34. LENGTH OF LITHIUM-FILLED PIPE REQUIRED TO DISSIPATE TRANSPORTED HEAT AT SEVERAL TEMPERATURES.

(B) CONDENSER EMISSIVITY, 1.0.

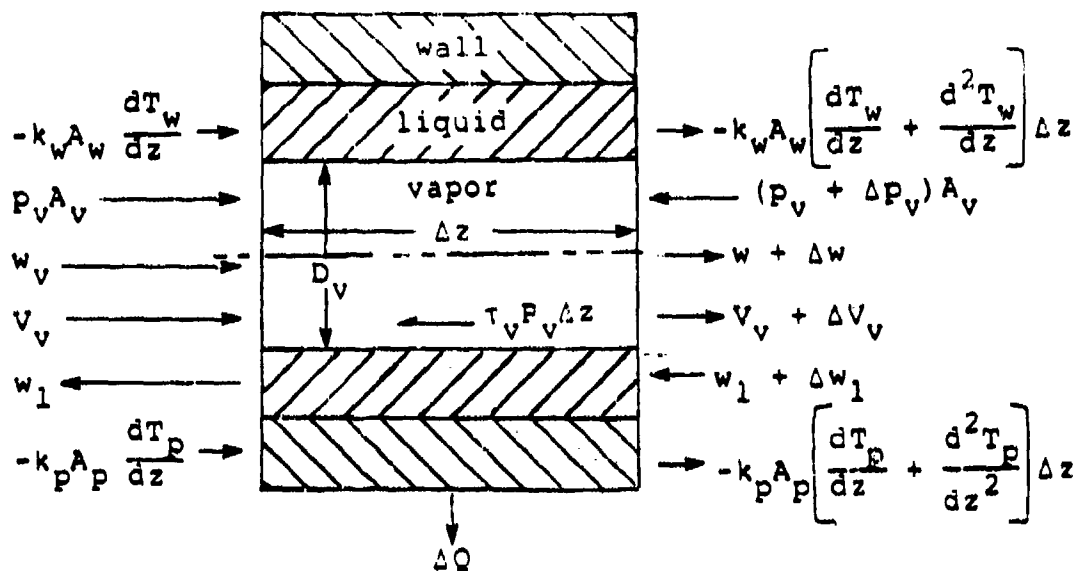
To facilitate computation of the flow in the condenser, a simple one dimensional flow analysis was constructed. The analysis differs from the customary one dimensional flow analysis of Shapiro (Ref. 13) since the control volume is drawn to include the heat pipe wall and fluid. By this means the conduction of heat along the heat pipe wall is easily accounted for. This sketch illustrates the model:
